July 31, 2012

MEMORANDUM

SUBJECT: Western berm inspection of armor cap at the San Jacinto River Waste Pits superfund site.

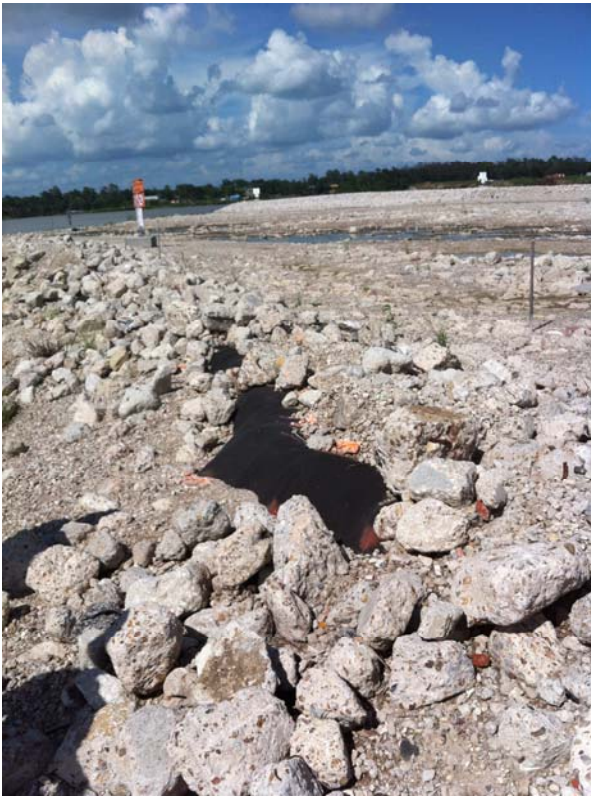
- No visible waste was observed to have been released above the water
- Several areas along the western berm have experienced bulging which is causing stretching of the geotextile fabric and LLDPE liner underneath
- Geotextile fabric and LLDPE liner that is exposed are observed to be in tact without any tearing or holes
- The western armor cap berm is still intact, but has experienced significant erosion due to unknown causes
- The RPs expect to have a repair plan submitted to EPA by Friday July 27, 2012 for review and approval
- The repair will involve a larger gradation of rock and is estimated to be completed in 2 to 3 business days from date of plan approval

Picture 1:- View of western berm erosion with exposed geotextile fabric

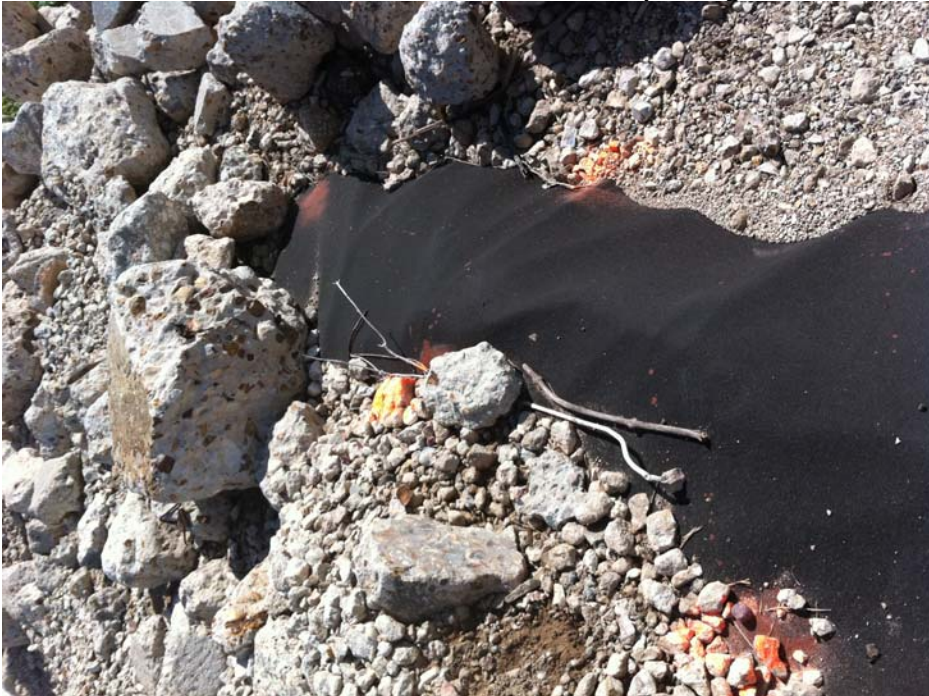
The fabric exposure along with areas of the western berm that have experienced bulging has raised concerns about the cap’s structural and environmental effectiveness. During the inspection it was observed that none of the areas of exposed geotextile fabric had any tears, but concerns remain about effectiveness due to the fabric stretching caused by the underlying waste bulging underneath.

Picture 2:- Close up picture of exposed geotextile fabric

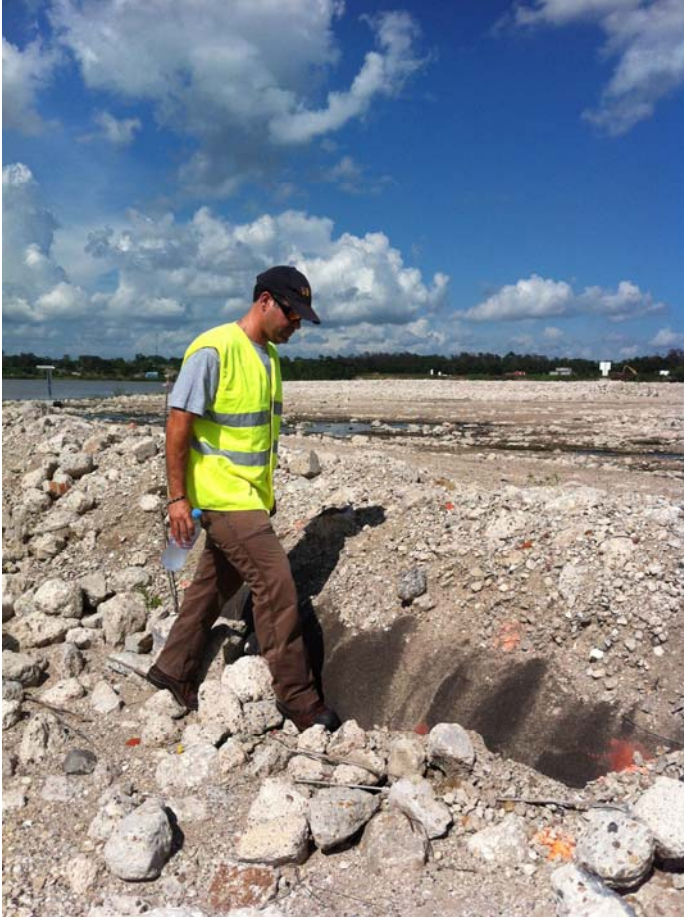
Picture 3:- View of OSC Leos standing next to berm illustrating extent of cap erosion
